Blast Loading and Response of Murrah Building

Abstract

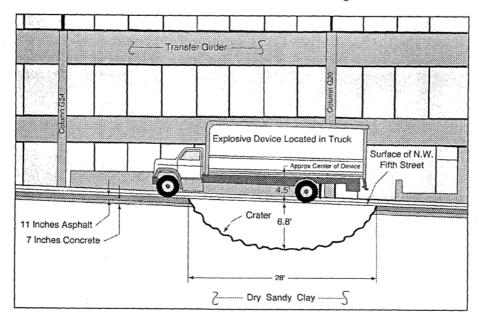
The crater, Figure 1, was approximately 28 ft in diameter and 6.8 ft in depth. According to the design drawings and observations on site, the thickness of the pavement was 18 in. and the underlying soil was dry sandy clay. From information about the truck reported to have contained the explosive device, the center of the explosive is estimated to have been 4.5 ft above the ground surface.

Figure 1. Bomb Crater at North Face of Murrah Building

As summarized in Table 1, the detonation of TNT having a mass of 4,000 lb results in a crater whose dimensions are consistent with those measured at the Murrah Building. The equivalent mass of TNT is used here, as is the practice in explosive effects, as a measure of the energy yielded by the bomb. In this analysis, the crater dimensions for pavement on soil are an average of those for massive concrete and for those on dry sandy clay alone. The individual dimensions were computed from empirical equations fit to extensive test data (Department of the Army, 1986). These were weighted in proportion to the depths of the two materials in the crater. This is substantiated by the results of ongoing research concerning craters in pavements with an underlying soil base.

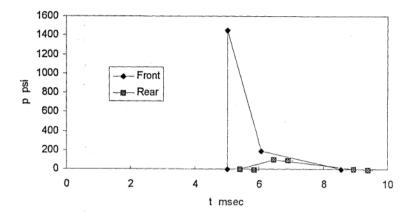
Figure 3 shows the blast loading on Column G24. On the front face, the peak load p₀ rises abruptly to the reflected pressure, 1,400 psi. When the blast clears this face, it falls to the sum of incident and dynamic pressures. The blast

subsequently arrives at the rear face and rises gradually to the sum of the incident and dynamic pressures at this range and orientation. The effective triangular duration t_d of the net loading is only 1.3 msec.

Figure 3. Blast Loading of Column G24

Most of the response of Column G24 occurred after the net load diminished to zero so that it was an impulsive structural event. In this response the maximum shear V_m induced at the supports is 1.8 times V_u and a brittle failure of the element ensues. As the axial prestress and corresponding shear capacity are greater at the first-floor than at the third-floor, this failure is expected at the top. Immediately after the blast, this column was missing from above the first-floor, in agreement with the results of this analysis.

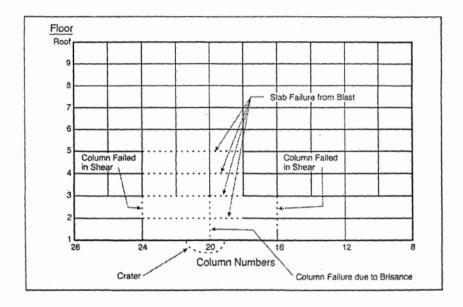
Similar analyses were performed for the other floor and roof slabs in the building and are summarized in Figure 5. In particular the floor slabs in the fifth-floor and below between Column Lines 18 and 24 were sufficiently loaded by the blast to fail as shown. The inward extent of this directly induced failure was estimated to be 40 ft at the second-floor and to diminish to zero at the sixth-floor. However, the other slabs responded elastically to the differential blast loading and in some cases were not loaded above the static downward loads.

Figure 5. Blast Response of Slabs
